OPERATING EXPERIENCE WEEKLY SUMMARY

Office of Nuclear and Facility Safety

October 2 - October 8, 1998

Summary 98-40

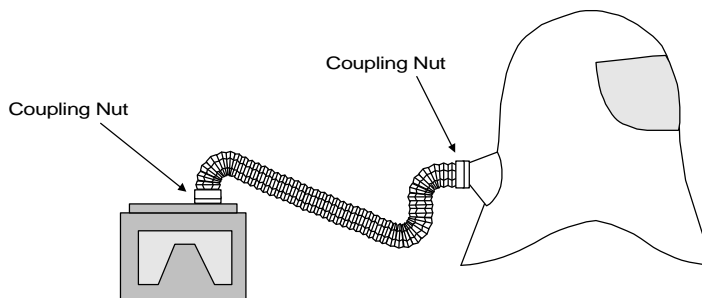
Figure 2-1. MSA OptimAir 6 PAPR

In September 1998, at the Fluor Daniel Hanford site, a respirator protection program administrator discovered that five fractured Mine Safety Appliance (MSA) coupling nuts had recently been found on 19-inch hood breathing tubes, three of which were new and still in the manufacturer's boxes. The tubes have plastic coupling nuts on both ends that connect Powered Air-Purifying Respirators (PAPR) to MSA blower units. The respirator protection program administrator notified MSA personnel of the fractured coupling nuts. They determined that the failures had resulted from a solvent attack on the polycarbonate material during the manufacturing process. These failures are similar to three failures that occurred at Hanford two years ago. Failure of the coupling nuts could result in radiological uptakes.

Investigators determined that all of the nuts have fractured horizontally and that all of the failures have been associated with MSA OptimAir 6 PAPR (see Figure 2-1). Respiratory protection personnel restricted use of these models and the MSA product lines manager has stopped all

shipments of this PAPR until the anomaly can be resolved. MSA personnel will change to a solvent-resistant plastic for manufacturing of the coupling nut. They will also issue field inspection test instructions so all PAPR that contain the polycarbonate coupling nuts can be checked before use. In addition, respiratory protection personnel have notified the National Institute for Occupational Safety and Health of the coupling nut failure.

Facility managers and personnel in charge of training workers on respirator usage should emphasize the importance of carefully checking for respirator defects before entering areas that require respiratory protection. Personnel who wear respirators should ensure that they understand and implement the correct methods of wearing, operating, and checking the respirators. DOE/EH-0256T, *Radiological Control Manual*, 29 CFR 1910.134, *Respiratory Protection*, and ANSI Z88.2-1992, *Respiratory Protection*, discuss equipment and requirements of respiratory protection programs and provide additional references.
